Top Cap

Part Number for Rear UHMW Bushing 6420/6220: 150566
 Part Number for Top Stinger Cap Kit: 106785

Inspecting Bushings:

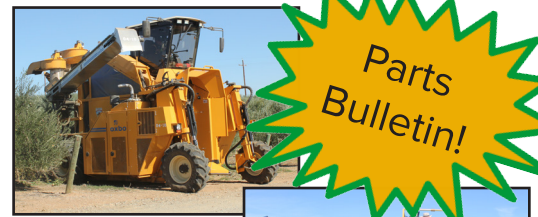
Locate the rear leg cap. The leg cap is attached using two bolts and covers the tube and bushing.

Remove the cap. (The UHMW bushing is bolted onto a welded cap on the stinger.)

The bushing shown above is in good condition. Note the area where the technician checked for grease and the tight fit of the bushing in the sleeve.

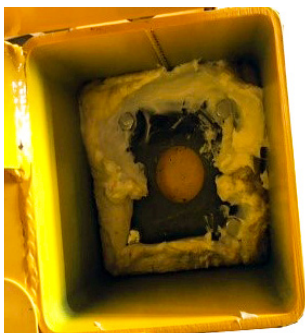
Bushing w/notch showing.

Top Plate is in Good Condition, With Welds All Around

Before installing a new bushing, be sure to inspect the top plate on the stinger (inside). Be sure that this top plate is securely attached with welds all around. If it is in good condition, then install a new bushing.

Unbolt the UHMW bushing and top cover plate. Remove top cover plate and wipe away grease from the edges of the bushing. Inspect the bushing for wear. If there is more than 1/8" of play (gap) between the bushing and the inside of the tube, the bushing should be replaced. The easiest way to measure that gap is to use a piece of 1/8" thick steel and try to insert it between the plastic bushing and the steel tube.

1. Align the notch in the bushing toward the inside of the picking tunnel.
2. Slide the new bushing down inside the tube and then onto the stinger.
3. Replace the steel top cap and the bolts to retain the new bushing to the stinger tube.
4. Grease the inside of the tube.
5. Then replace the top cover.

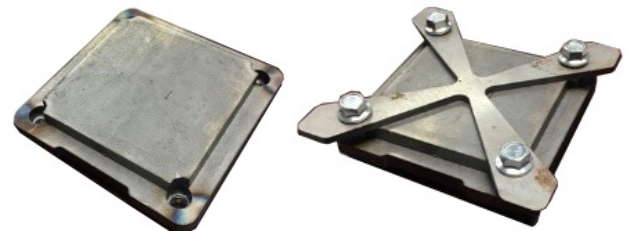
Top Plate is NOT in Good Condition, Lack of Welds, or Off Completely

In some cases where bushings have not been inspected at regular intervals and have not been replaced when worn, damage to the top of the stinger can result.

If you see the UHMW bushing detached from the stinger:

First, you will need to purchase both a new bushing and a top stinger cap kit (Oxbo part number 106785). The kit includes a new stinger steel top cap (must be welded onto the existing stinger) and an alignment star to aid in welding the new top cap on the existing stinger.

Next, weld the replacement cap onto the stinger. Then, install the new bushing:

1. Align the notch in the bushing toward the inside of the picking tunnel.
2. Slide the new bushing down inside the tube and then onto the stinger.
3. Replace the steel top cap and the bolts to retain the new bushing to the stinger tube.
4. Grease the inside of the tube.
5. Then replace the top cover.
